Man loses arm in baling machine

A worker suffered a catastrophic injury while operating a baling machine that was used to bale the black plastic sheeting used on strawberry fields. We were experts for the plaintiff. A full investigation was made of the machine—its design and operation. Applicable design and operation codes for the machine were investigated. Comparable injuries were investigated too, e.g. injuries involving conveyor belts. A number of flaws in the machine were found.

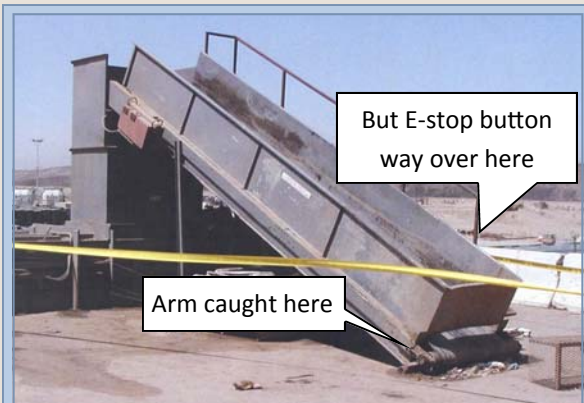
Plastic baler, showing location of injury and relative location of E-stop.

Last, emergency stops were not located at every pinch point. In this case, the worker said he saw the accident occurring in slow motion. Had there been an emergency stop right at the pinch point where his arm was drawn into the machine, it is likely his injury could have been prevented or its severity reduced.

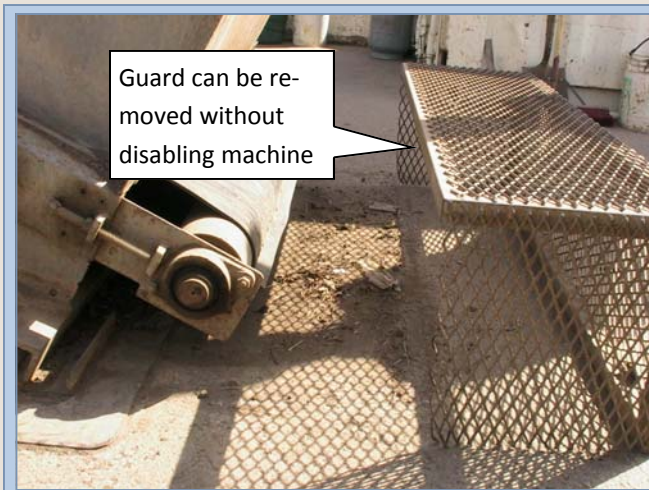
No measures taken to prevent guard removal.

In investigating the manufacturer of the baling machine, it became evident that the level of engineering invested in its design was poor. Also, the machine was controlled by a programmable logic controller (PLC). There are various ways to integrate a PLC into a machine or system, and it was found that the PLC/machine integration in this case was non-optimal. In case of emergency, if the emergency stop button was pressed, the power to the machine was cut in a questionable manner, and it depended on the fool-proof operation of the PLC's operating system. Also problematic was that the machine was designed and manufactured with no thought-out cataloging of failure scenarios. It is good and accepted engineering practice to identify possible failures and dangers and then to design them out of the machine. Guards and shields against moving parts and pinch points were poor and could be removed without disabling the machine.

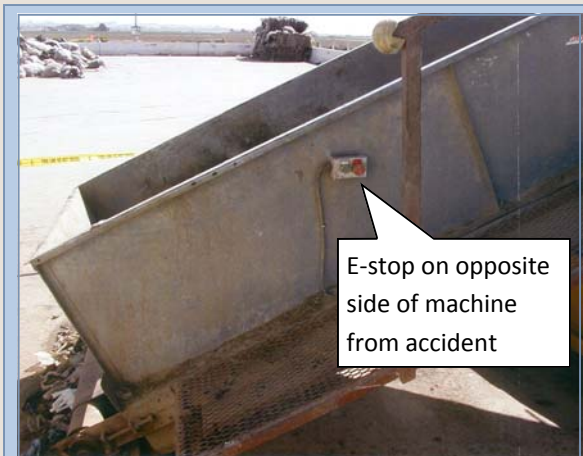
Emergency stop button on opposite side of machine from accident.
